**Second  
International Conference  
on  
Case Histories in  
Geotechnical Engineering**

**June 1-5, 1988**

**University of Missouri-Rolla  
Rolla, Missouri**

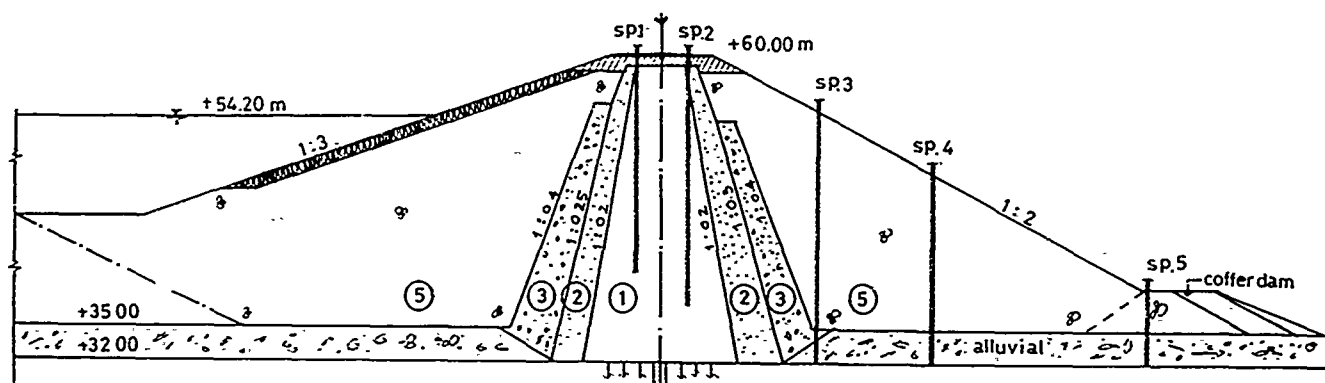
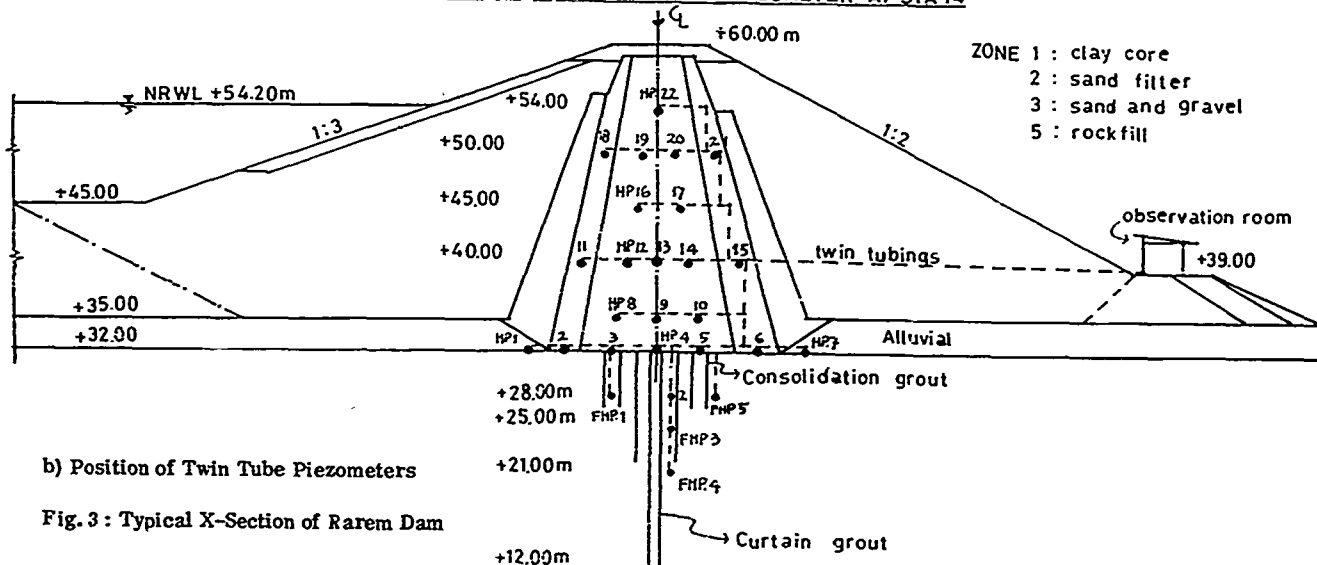
a) ARRANGEMENT OF STANDPIPE PIEZOMETER AT STA 14

b) Position of Twin Tube Piezometers

Fig. 3 : Typical X-Section of Rarem Dam

Hydraulic tips were embedded both in embankment fill and in foundation of dam. Tips in foundation were installed in drilled holes while in embankment, were placed at specified locations as fill progressed. Tips were carefully saturated with deaired water and taken to the site under water. The connecting tubes which were also deaired from the observation room by flushing with deaired water, were connected to the tip under water. The location of tips in dam section is shown in Fig. 3(b).

From this figure, it can be seen that five foundation tips have been installed in tuff rock foundation. Piezometers FHP 1, 2 & 5 have been embedded at El. + 28.0 where as FHP 3 is at El. +25.0 and FHP 4 at El. + 21.0. In all 22 piezometers have been installed in embankment in 6 tiers viz. 7 nos. (HP 1 to HP 7) in first tier (El. + 32.0 m), 3 nos. (HP 8 to HP 10) in second tier (El. + 35.0), 5 nos. (HP 11 to HP 15) in third tier (El. + 40.0), 2 nos. (HP 16 & HP 17) in fourth tier (El. + 45.0), 4 nos. (HP 18 to HP 21) in fifth tier (El. + 50.0) and one piezometer HP 22 in sixth tier at El. + 54.0. Piezometers HP 1 & HP 7 are installed in alluvium, HP 11, HP 15 HP 18 and HP 21 are in sand filter zone and balance are in clay core. Though the construction of dam started in November 1981 but the installation of foundation type piezometers could be started in July 1982 after completion of grouting. By that time, the fill attained the elevation of + 37.0 m.

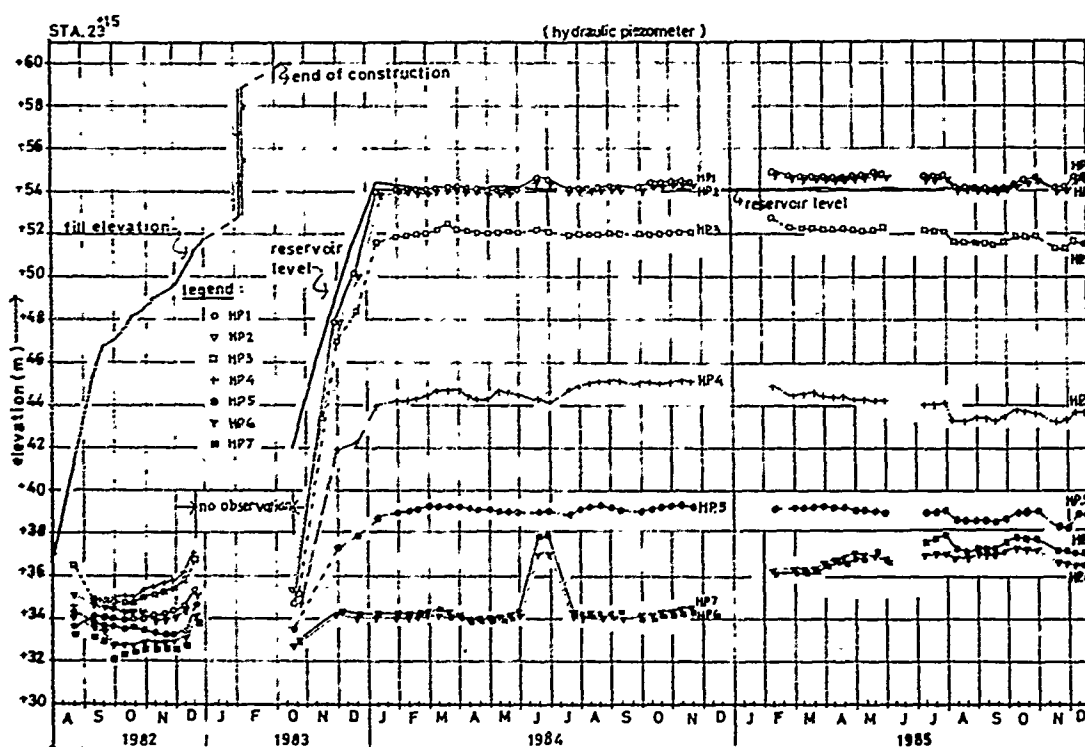
Fig. 4 : Pore Pressure Observations in First Tier

Observed pore pressures from August 82 to December 1982 and from mid October 1983 to December 1985 for embankment piezometers HP1 to HP7 are shown in Fig. 4. A study of pore pressures recorded from August 82 to December 1982, indicates that tips no. HP1 and HP2 embedded in river alluvium and filter zone respectively upstream of clay core at El. +32.0m, have recorded almost constant pore pressures of the order of 2 to 2.5m of water head. Since the water level in the river, was at El. +34.0m, obviously these tips recorded pressures corresponding to river water level. Pore pressures recorded by tips No. HP6 and HP7 buried downstream of core in filter zone and alluvium respectively, are of the order of 0 to 1 m and are thus lesser than those recorded by tips located upstream of clay core in similar type of strata. Pore pressures measured by HP3 and HP4 embedded in the clay core show that their values tend to follow the increasing trend as height of embankment fill increases. Their values vary from El. 35.0 to 37.0 m i.e. pore pressure head of 3 to 5 m of water head. At 5m pore pressure head, corresponding dam height is 19m indicating thereby development of pore pressures of the order of 0.4H only. Other tips viz. HP8 to 10, HP12 to 14

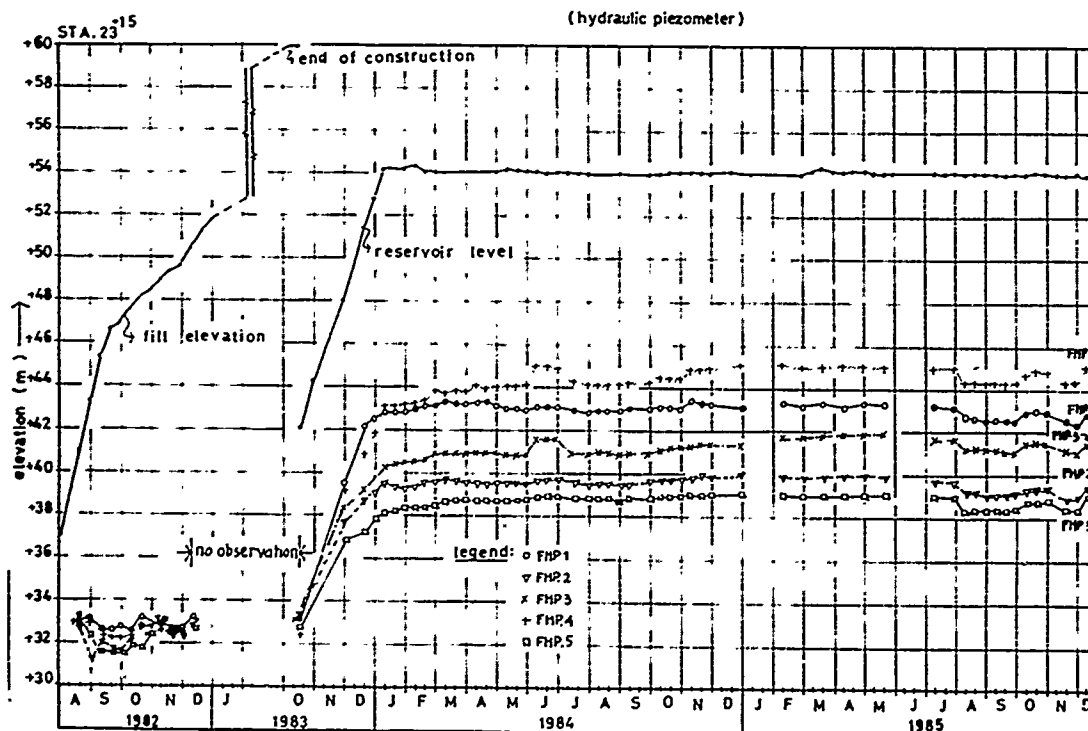
Pore pressure observations in FHP1 to 5 alongwith reservoir

Fig. 5 : Pore Pressure Observations in Foundation

filling pattern are shown in Fig. 5. During reservoir filling period (October to December 1983), these tips have recorded increase in pore pressures following the pattern of reservoir level raising almost simultaneously. Since the reservoir level has remained almost constant from January 1984 onward, the pore pressures recorded by these five foundation tips are also almost constant during this period and the variation of the order of  $\pm 1.0$  m of water head may be due to inherent limitation of the instrumentation. Observations during and after reservoir filling indicate that for FHP1, 2 & 5 located at El.+27.0m, the pore pressures reduce from tip no. 1 to 5 indicating thereby the effect of consolidation grouting done upto El.+27.0. The pore pressures at tips Nos. FHP1 & 5 are of the order of 16m and 12m. respectively against reservoir head of 28.0 m. Tip no. FHP4 located downstream of grout curtain and at lowest level (El.+21.0m) has recorded highest pore pressures which are higher by about 2m head of water from those recorded by FHP1. Similarly tip no. FHP3 also located downstream of grout curtain at El.+25.0m, has also recorded higher pore pressures by about 2.0m as compared to tip no. FHP2. Recording of higher pore pressures by tips no. FHP3 & 4, is contrary to the expectations.

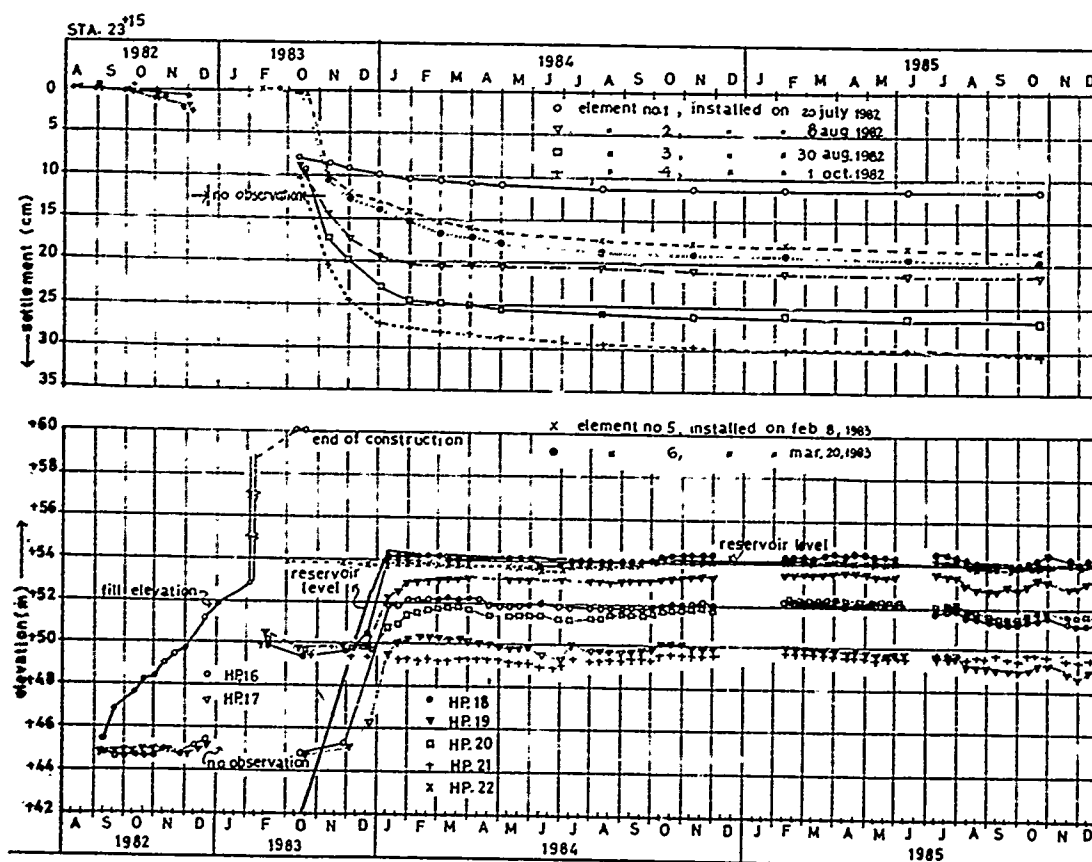
Fig. 6 : Pore Pressure and Settlement Observations

A study of Fig. 6 showing settlement data, indicates that during construction period (August to December 1982), the settlement recorded, varied from 0.5 cm to 2.5 cm, the smallest value was recorded by settlement plate no. 1 embedded at bottom most level at 32.773 and highest by plate no. 4 at El. +46.736 m. No significant settlement was recorded by plates no. 5 & 6 from their installation in February and March 1983 until October 1983 when reservoir filling started. At the end of construction in October 1983, the settlement of the order of 8 cm to 10.5 cm was recorded by plates no. 1, 2, 3 and 4.

During reservoir filling from October to December 1983, a steep rise in settlement is recorded by almost all plates. In case of plate no. 4, the settlement increased from 10 cm to 27 cm. For plate nos. 5 & 6 (El. 50.90 and 56.41m), increase in settlement was of the order of 12-13 cm by end of December 1983. Plates no. 1, 2 (El. 37.439) and no. 3 (El. 41.924), indicated rise during this period from 8.5 to 10 cm, 9 cm to 20 cm and 10 to 23 cm. respectively. This shows that depending upon the location of plate, maximum settlement has been recorded during reservoir filling which is of the order of 13 to 17 cm for plates located in

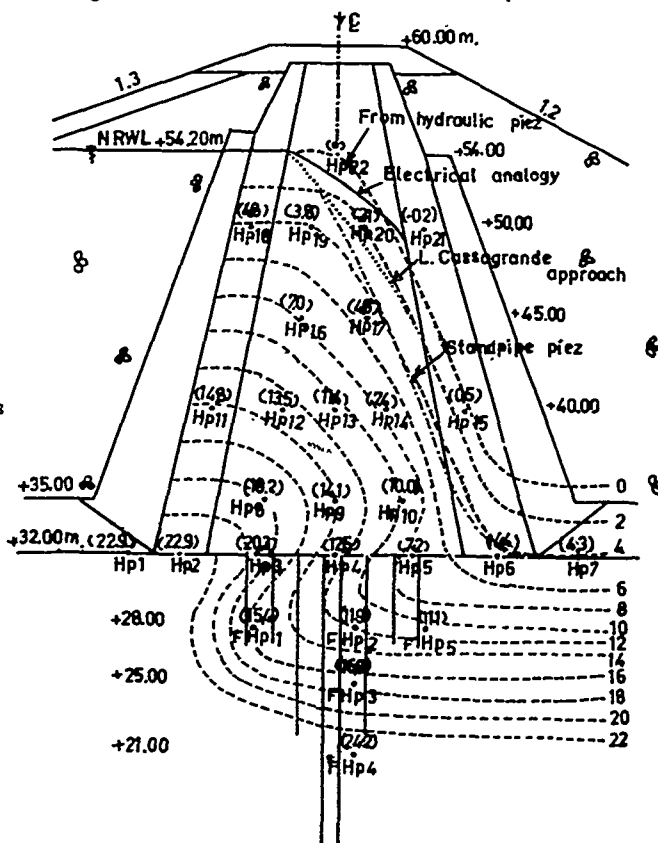
Fig. 7 : Equipore Pressure Contours and Phreatic Surface

Equipore pressure contours for readings taken after fifteen months of reservoir filling (March 1985) are shown in Fig. 7. A study of this figure would indicate that the effect of anisotropy in the permeabilities of clay core, foundation treated by consolidation grouting and that of untreated foundation, is noticeable.

Free surface line as obtained from observations of twin tube hydraulic piezometers and that obtained by vertical stand pipe piezometers no. SP2 is shown in Fig. 7. From this, it can be seen that free surface line obtained by twin tube piezometers is higher as compared to that given by vertical stand pipe no. SP2. Free surface line has also been drawn by L. Cassagrande's approach presuming foundations to be impervious. Free surface line with this method lies in between the two observed free surfaces. Free surface line has also been drawn by electrical

analogy method taking permeability of clay core, consolidated grouted foundation zone and ungrouted foundations as  $6 \times 10^{-6}$ ,  $6 \times 10^{-4}$  and  $1 \times 10^{-3}$  cm/sec. respectively and the same is also shown in Fig. 7. It is seen that the free surface obtained by electrical analogy, coincides fairly well with the free surface obtained by twin tube piezometers. Thus the observational data of Bishop's type piezometer can be treated as reliable.

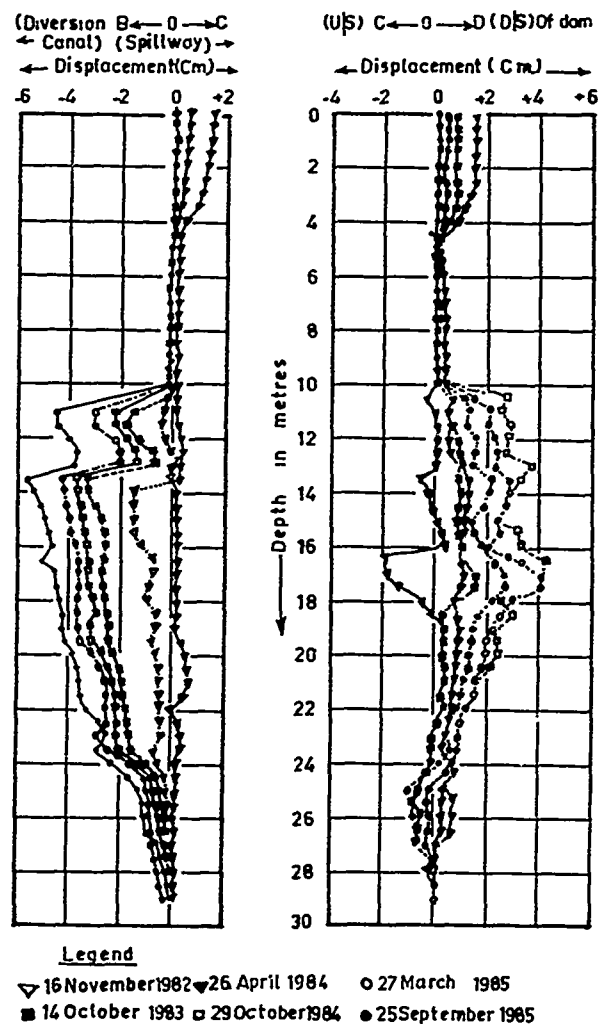
Fig. 8 : Observational Data for Horizontal Movement  
ELECTRICAL ANALOGY EXPERIMENTAL RESULTS

A close look of Fig. 8 indicates that height wise, there are three distinct regions so far as horizontal movement is concerned. One is from top of dam to 4 m depth, second is 4 m to 10 m depth and third is 10 m depth to bottom most anchor point in foundation. In second zone, there is practically no movement either along the axis or perpendicular to it. In first region (top 4.0 m), downward movement of about 1.5 cm is recorded after 4 months of reservoir filling but it has returned to normal position by Sept. 1985 confirming that there is no downward movement. Similar is the trend for movement along dam axis in this region. However, in region 3 (10 m from top until foundation), maximum downward movement of the order of 4 cm from normal has been recorded after 10 months of filling (29th October 1984) which has subsequently reduced to 2.0 cm after one year (29th Sept. 1985). The movement towards diversion canal is increasing with time and has attained deflection of the order of 6.0 cm.

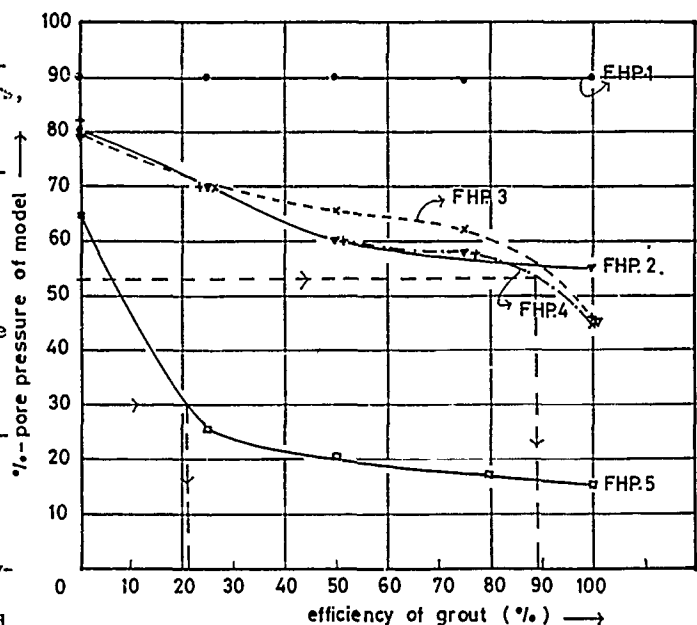
Fig.9 : Grout Efficiency vs Percent Pore Pressure

From Table 5, it is seen that percent pore pressures of FHP1 from model studies are almost constant for various cases of grout efficiencies and are of the order of 90% irrespective of the fact that even if the grout curtain as well as consolidation grout is fully ineffective where as observed pore pressure in field is only 51%. This observed value seems to be too low and is not explainable even by model test results. Recording of low observed values may be either due to malfunctioning of tip or due to creation of some what impervious zone due to grouting around the tip. Observed pore pressure of FHP2 located downstream of grout curtain, is of the order of 35% whereas those observed on model, vary from 55% to 79%. The pore pressures as observed in the model are increasing as the efficiency of grout curtain is increasing. Reasons for low observed pore pressures recorded by tip no. FHP2 may be the same as for FHP1. Perhaps consolidation grout is very effective below dam core. Observed pore pressure of piezometer no. FHP5 located at same elevation as that of tip no. FHP1 and FHP2 (+28.0m) is of the order of 30% whereas those observed on model, vary from 15% to 65%. If it is presumed that actual field observation is correct, it may be concluded that grout curtain is efficient only to the extent of 21%

(Fig. 9). Reason for higher observed pore pressures in this tip, may be poor quality of consolidation grouting in this region. Permeability of foundation varies from  $7 \times 10^{-5}$  cm/sec. to  $0.84 \times 10^{-3}$  cm/sec and the assumption of average permeability of consolidated area as  $6 \times 10^{-4}$  cm/sec (100K) uniformly throughout, may not be correct.

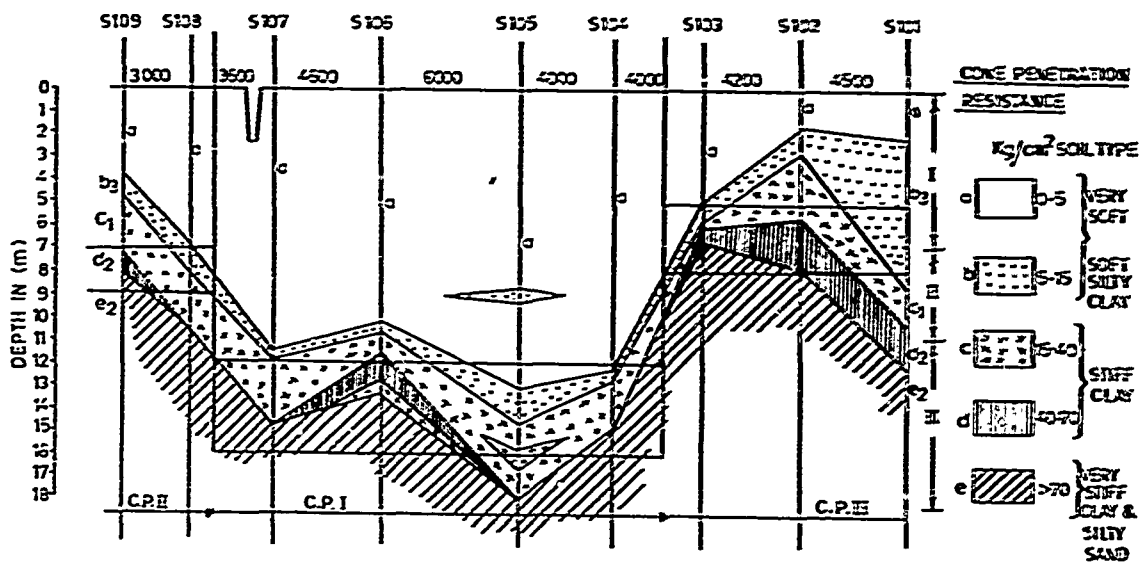
FIG. 1. GEOLOGICAL FORMATION DETAILS IN FOUNDATION ALONG AXIS OF MANGGAR BESAR DAM

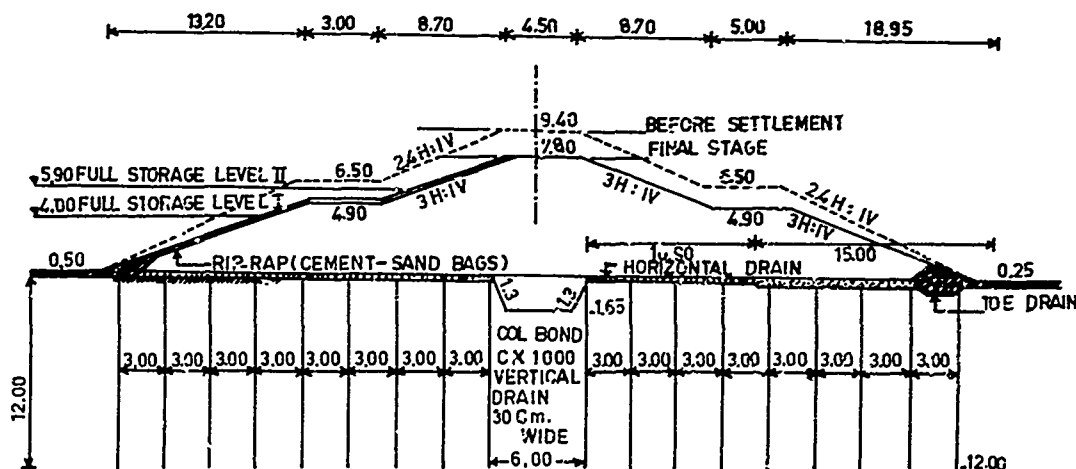
FIG. 2 TYPICAL CROSS SECTION OF MANGGAR BESAR DAM

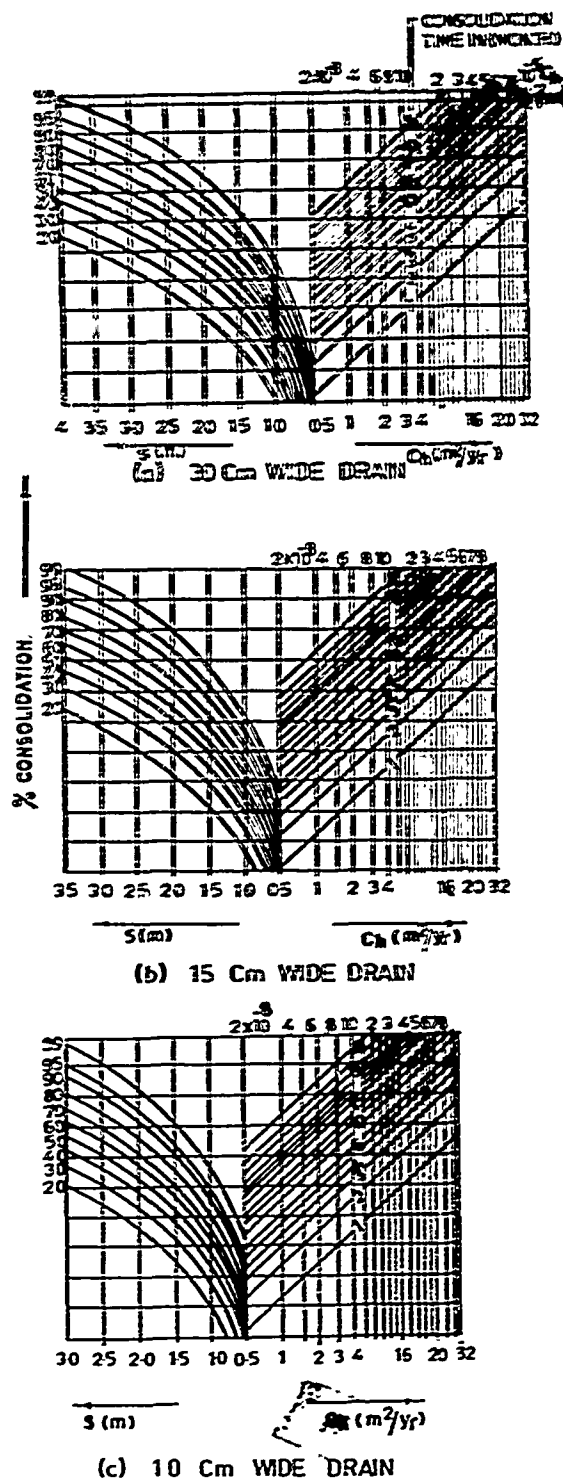
FIG. 3. DESIGN MONOGRAMS FOR COLBOND DRAIN

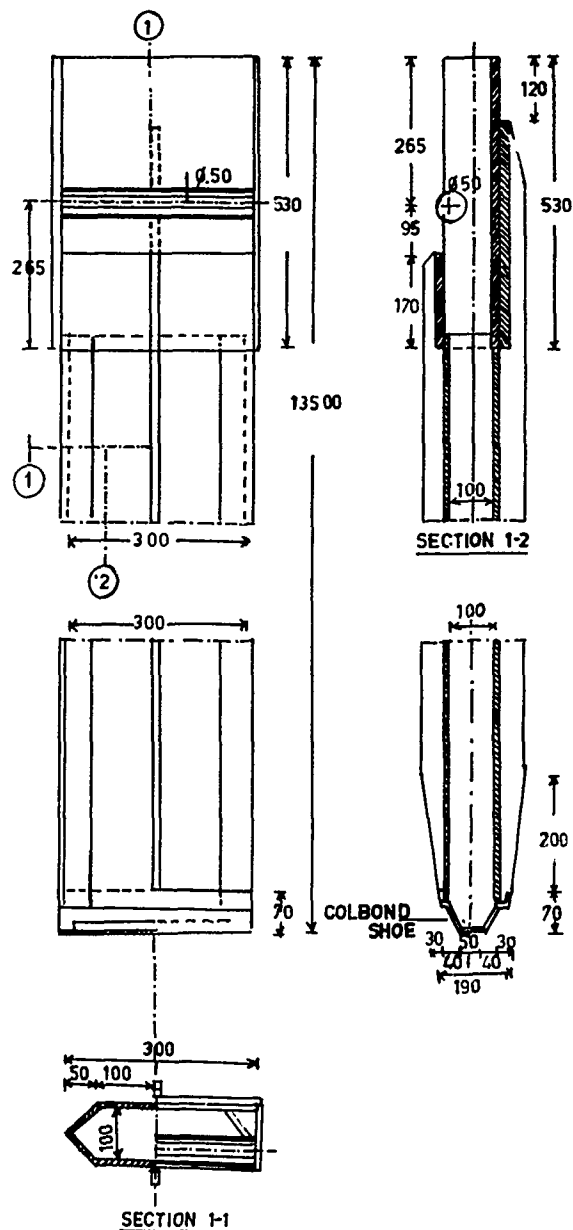
FIG.-4 MANDREL DETAILS

For easier movement, generator set required for vibrohammer was fitted with crawler crane unit. Rolls of Colbond CX1000 were fitted to the front of crawler crane. Mandrel was prepared at job site and its details are shown in Fig. 4. Colbond drain was fitted to the shoe of mandrel to be left in situ after pushing the drain upto required depth of vibrations and then mandrel was withdrawn. After installation of vertical drain, it was cut off about 20-30 cm above ground surface level of horizontal drain and the trench of the same was filled manually by sand of suitable grade.

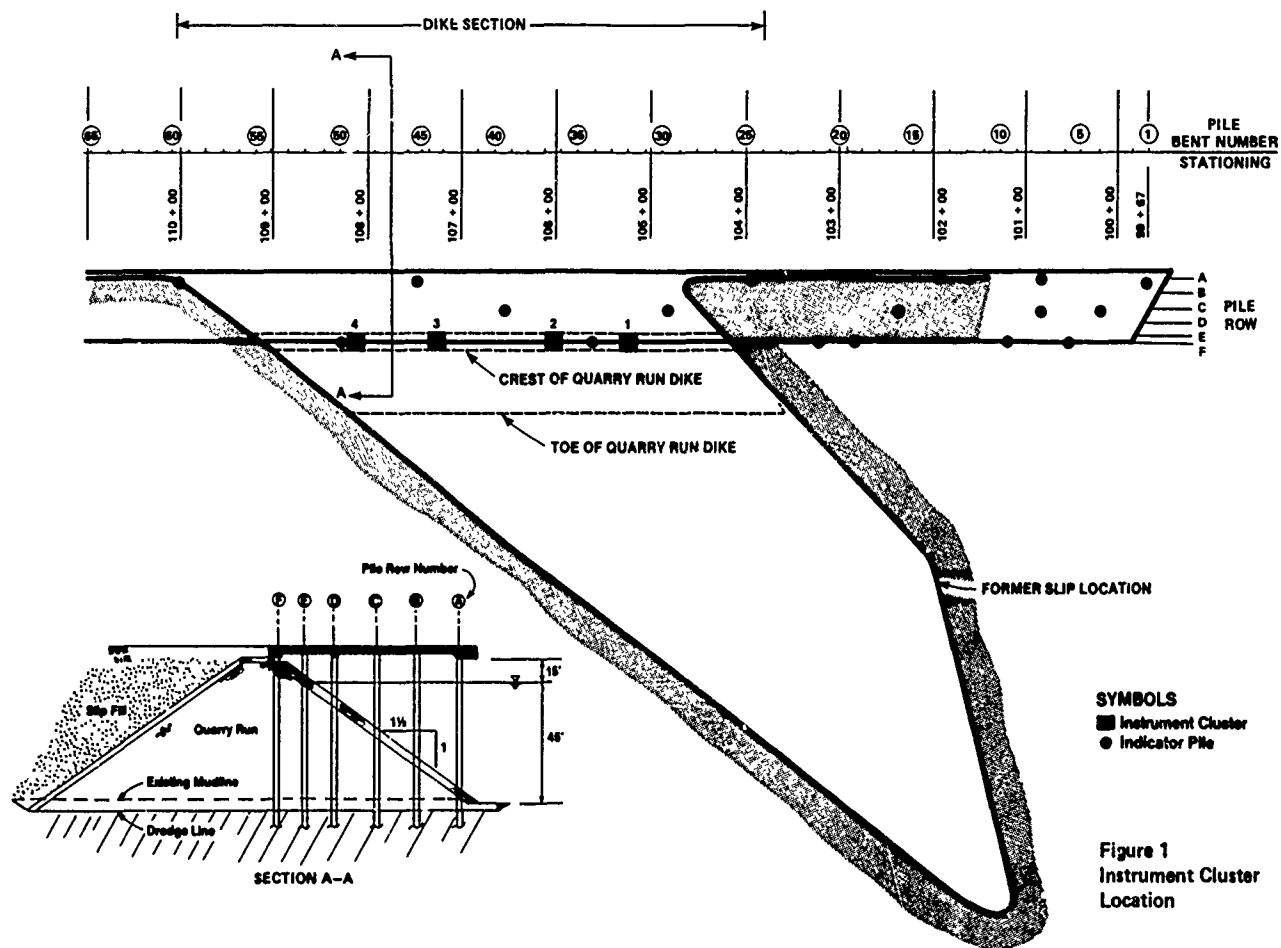
Figure 1  
Instrument Cluster  
Location

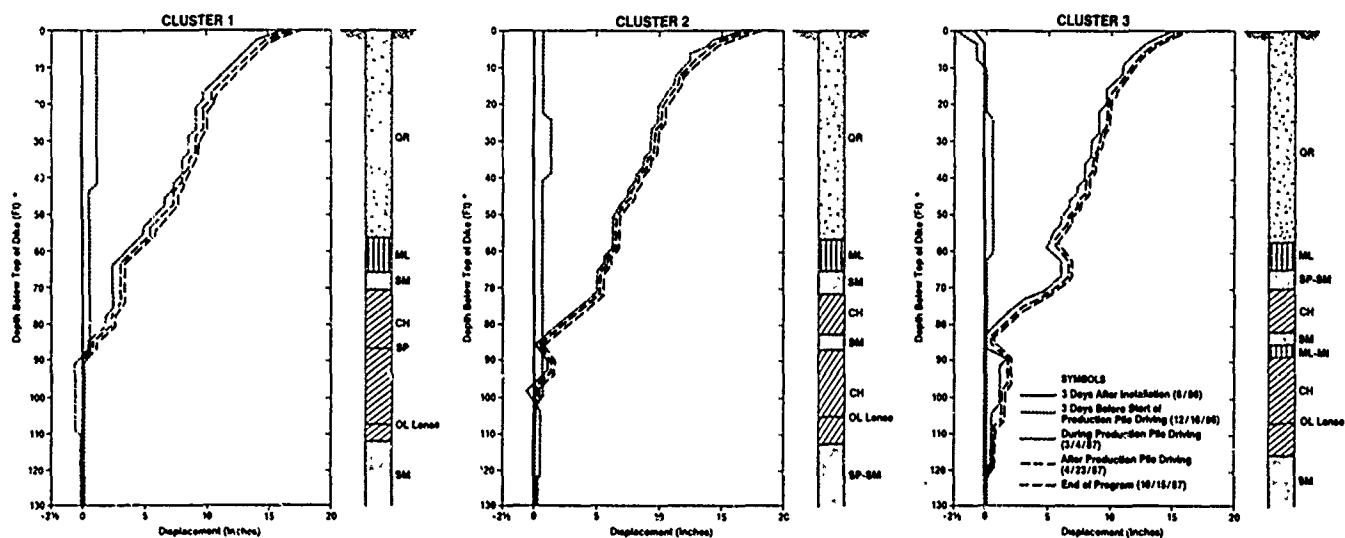
Figure 3  
Inclinometer Profile  
Plots for Instrument  
Clusters

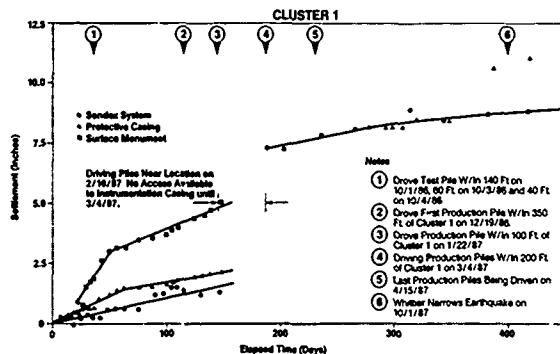
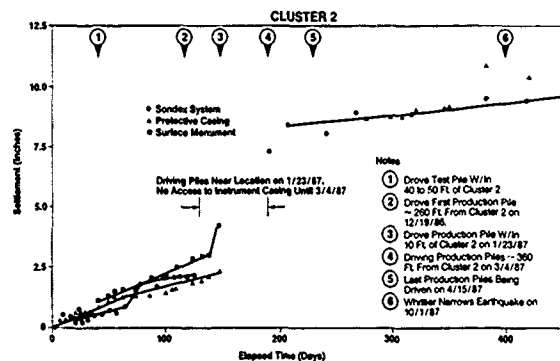
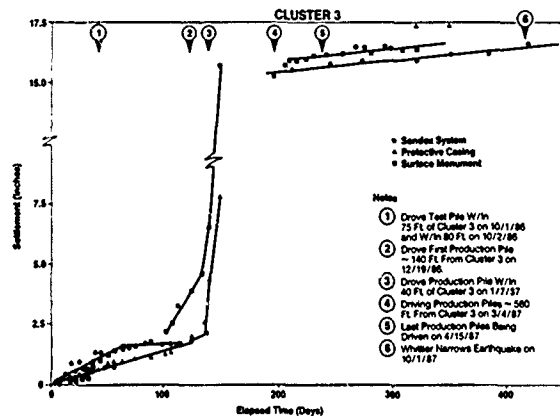
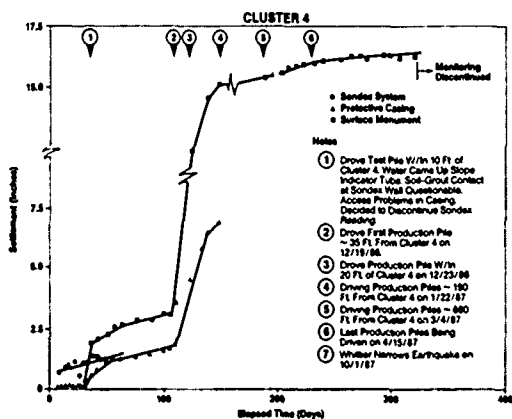
**Figure 4**  
Settlement  
Results

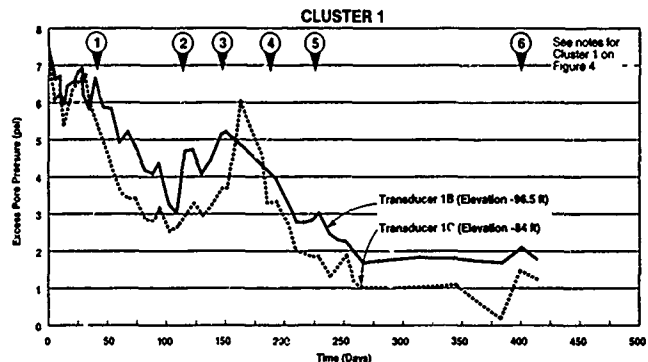
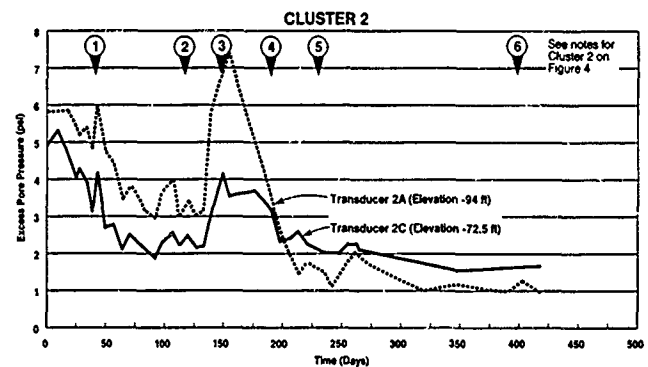
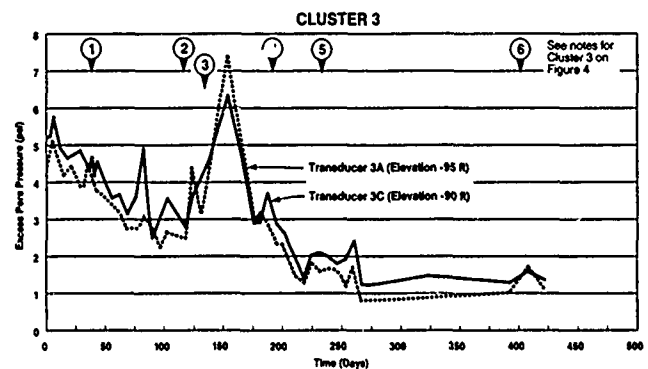
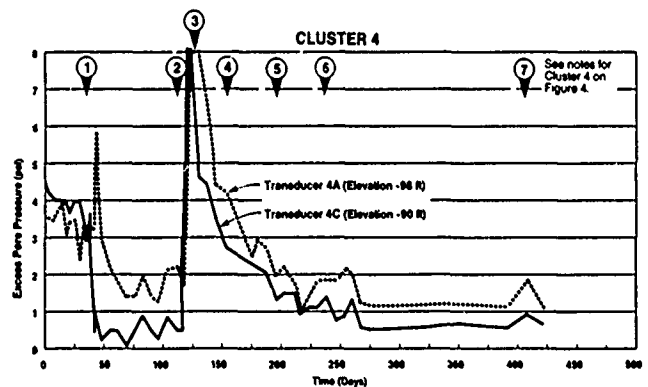
**Figure 5**  
Excess Pore Pressure  
as a Function of Time

The Whittier-Narrows earthquake appears to have caused an increase in pore pressures within the fine-grained soil of approximately 0.5 psi. The magnitude of this increase is somewhat surprising, given the distance from the epicenter and the magnitude of the earthquake ( $M=5.9$ ).

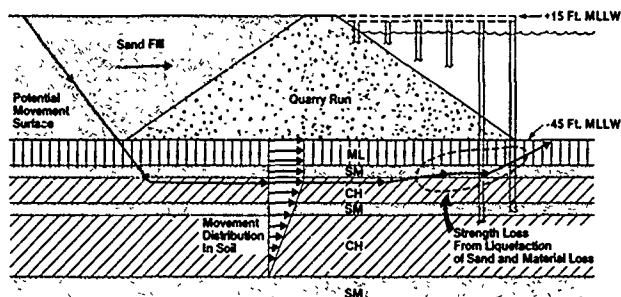
Figure 6  
Potential Mechanism  
for Dike Movement

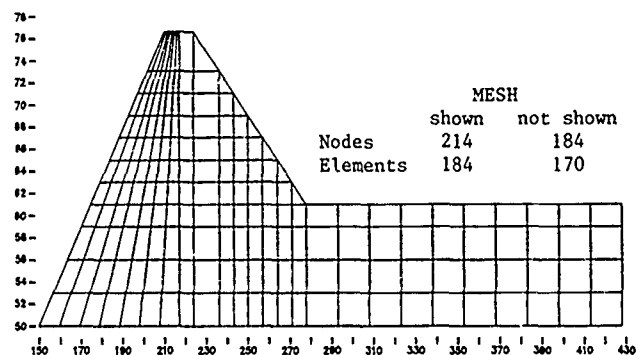
Figure 1. Basic Mesh (FEM)

A series of models were assembled to study a variety of realistic scenarios, these included removal of the downstream toe, vertical and horizontal sinkhole development, and elasticity closed solution checks. A mesh was also designed to indicate the confidence with which displacement magnitudes could be assessed and confirmed that pressuremeter soil parameters are appropriate. Observed field surface displacements are of the order of 2 feet. Cumulative addition of the surface depression settlements from this model, for a three stage development of a 10-foot wide sinkhole, reached a total of approximately 1 foot. This settlement results from the incremental depression when the dam weight is added as a post construction surcharge of a 30-foot width. It may be stated then that the general order of movements may be reasonable and the pressuremeter estimate of this phenomenon is acceptable as an approximation. The most significant models, using the mesh shown in figure 1, are then summarized below.

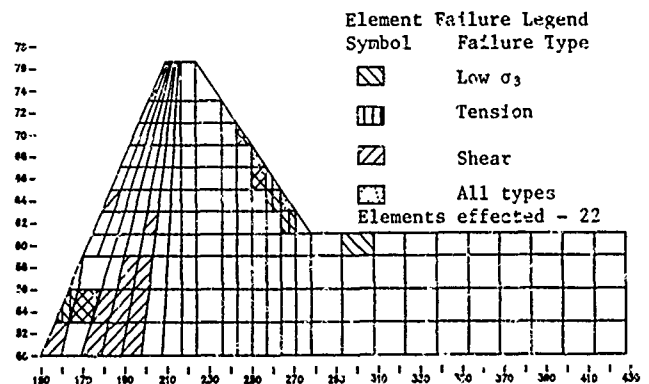
Figure 3. Increase in Distress Zones When Stress Relief is Considered.

The best estimate of all known conditions to model the construction with the exception of the cutoff was used. The 1:1 D/S toe slope was accommodated by using extremely soft properties (i.e., close to air) in the wedge to ensure no load would be taken by this zone (not by applying the post-construction forces). The output differences between this model and the previous are dramatic. If the extra zoning is ignored (not considered significant), the output shows the dam displays far less distress features when the construction to the 1986 profile is modeled. Removal of this downstream wedge, and hence the loss of horizontal support after construction was complete, IS HIGHLY SIGNIFICANT. A comparison of stresses between this and the previous model is shown in figure 3.

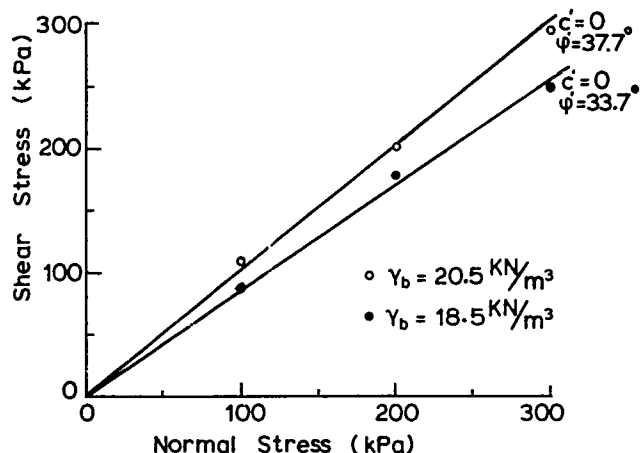
Fig. 2. Shear Strength Envelopes of fill material

Two series of tests were performed on prepared specimens with different water content and densities ( $\gamma_b = 18.5 \text{ KN/m}^3$ ,  $\gamma_b = 20.5 \text{ KN/m}^3$ ). Field densities and water content were previously determined in situ at different points and depths. The results from these shear tests are shown in figure 2.

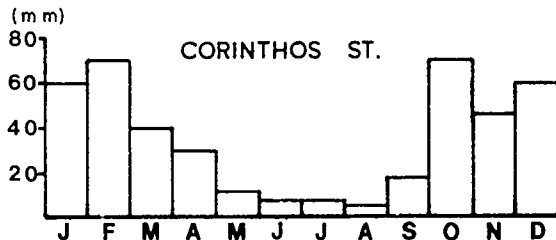
Fig. 3. Average Rainfall of Decade 1970-80

From the linear shrinkage, the x-ray diffraction, the swelling percent and the swelling pressure tests, was revealed that the fine portion of the fill material contained swelling clay minerals. In this area there are remarkable sequences of wet and dry seasons (Fig.3). After the impregnation of the embankment during the wet season, intense shrinkage of the material followed, during the dry period, caused the appearance of cracks (Fig.1). In order to avoid the rainwater percolation, through the cracks and fissures, which would cause the material to swell and slake, the following remedial measures have been taken.

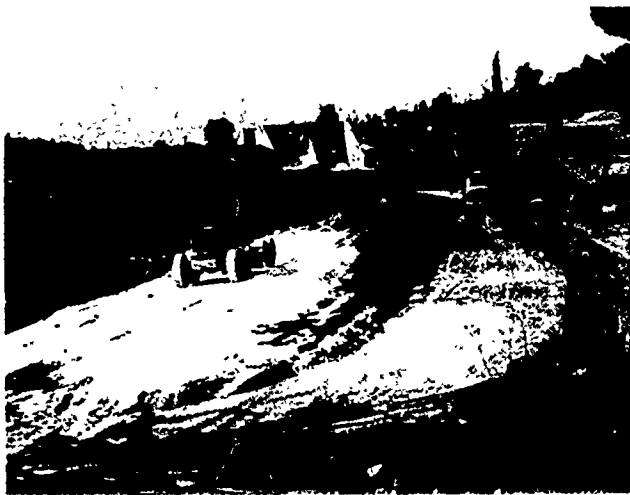
Fig. 4. Soil-Lime Mixing by Grader

The top three meters of fill material were removed by a bulldozer D8 and carried away by trucks loaded by a tyred shovel tractor. For the next layer, the first 25cm were removed and kept in place. The other 25cm were scarified by a grader ripper and mixed with five percent lime (Fig.4).

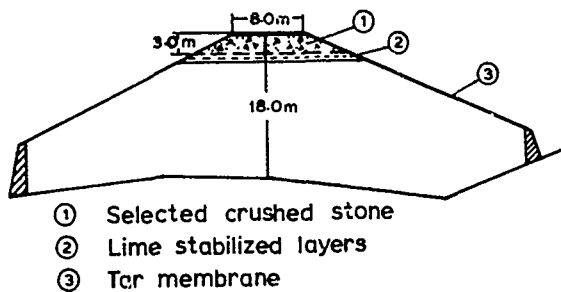
Fig. 6. Cross Section of Embankment after Remedial Works.

After the final level was reached, the full length of the embankment was protected from water percolation and moisture changes. For this, the surface was covered by a membrane of hot petrol emulsion ( $3.5 \text{ lit per m}^2$ ) and then an asphalt membrane was applied by a man-carried springler ( $7 \text{ Kg per m}^2$ ). Finally because the whole structure was too dark in colour, a thin layer of crushed stone ( $0.0-5.0 \text{ mm}$ ) was spread and stuck on top of the asphalt membrane. The above remedial measures are outlined in figure 6.

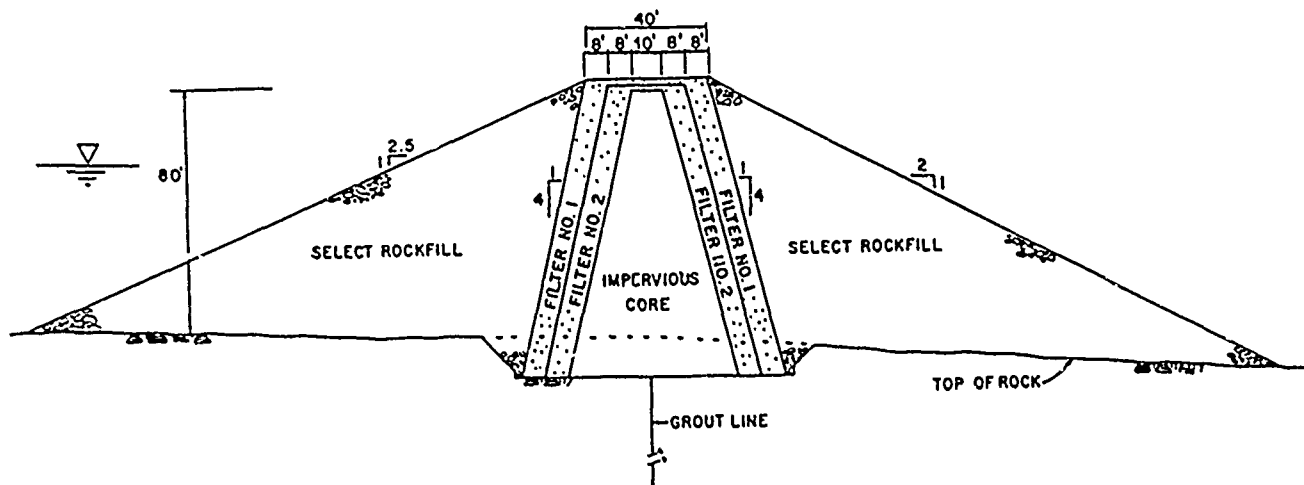
Figure 3. Section on Rock.

Bay Springs Dam has a zoned earth and rockfill embankment consisting of a central core, transition filters, select rockfill shells, and a cutoff trench, Figures 3 and 4.

The core has a top width of 10 feet with 4V on 1H side slopes. It consists of low plasticity clay compacted in a nine-inch loose lift by tamping or sheepfoot roller. The filters, fine and coarse, are eight feet wide with the fine filter No. 2, adjacent to the core, placed in 12-inch lifts compacted by a vibratory roller and having a gradation ranging from a No. 4 to a No. 100 standard sieve size. The coarse filter No. 1, between the shell and the fine filter is placed in 12-inch lifts compacted by a vibratory roller, and ranges in size from four inch to No. 4. The shells are placed in 24-inch lifts compacted by a vibratory roller and ranging in size from a maximum size of 16 inches to not more than 5% passing the 3-inch screen.

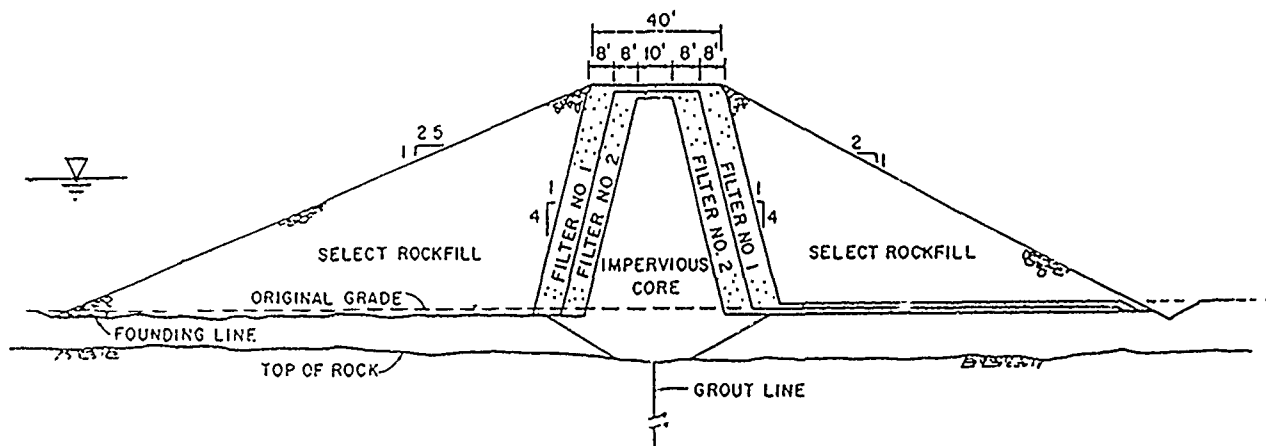
Figure 4. Section on Overburden.

A cutoff trench extends to rock in locations where the dam is founded on overburden. A grout curtain is provided to reduce seepage through the foundation. Measures were taken to dewater the area around the cutoff trench to reduce seepage during grouting and foundation preparation.

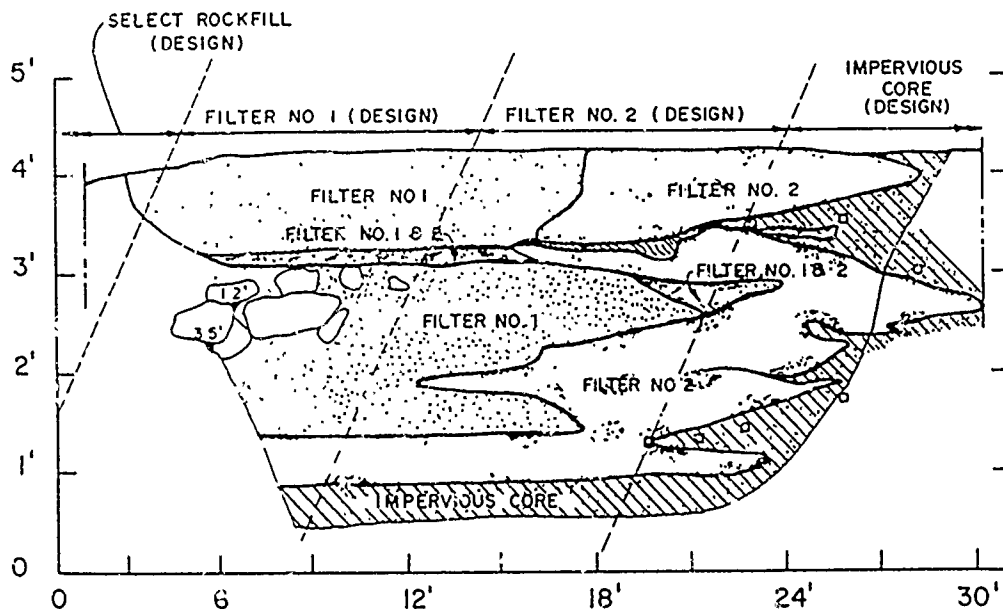
Figure 5. Overlapping Zones on Upstream Side of Embankment.

d. The filter zones and the core were intermingled and overlapping as shown in Figures 5 and 6.

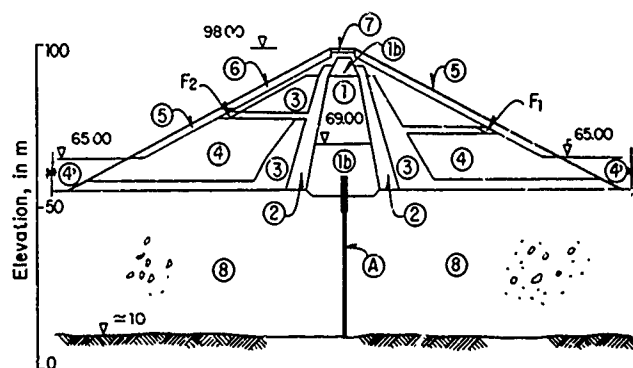
a) Maximum cross section of dam

b) Plan view

Peñitas Dam is a 43-m high earth and rockfill embankment with a central core of compacted residual clay, fig 1. The volume of materials

is  $2.76 \times 10^6 \text{ m}^3$ , its crest is 750 m long and it is founded on alluvial deposits up to 56 m thick. It has a plastic-concrete cut-off wall cutting the alluvium and embedded in the basal rock, fig 1; the first 12 m of the alluvial material were densified by dynamic compaction, Montañez and Castilla (1985). Two platforms made of waste rockfill material link the main dam with the upstream and downstream cofferdams.

**Impervious core (materials 1b and 1).** In this part of the dam two different kinds of clay were used, fig 1. Between the foundation and elev 69, as well as between elevs 90.5 and 95.5 and in two 5 m wide strips in contact with the banks all way up the dam, a brown plastic clay was placed, whose properties are shown in table 1 and in figs 2 and 3a (material 1b). Most of the core is made of residual silty red clay (MH and CH), whose characteristics are also shown in table 1 and in figs 2 and 3b (material 1). Both clays were compacted with water content 1-3% above the optimum.

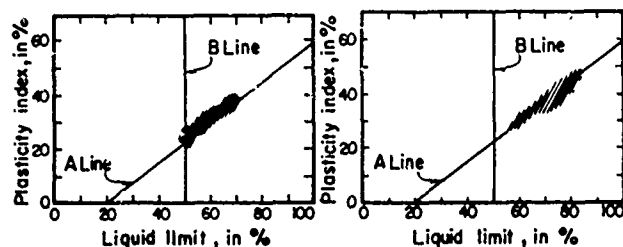
a) Plastic brown clay      b) Red silty clay

Fig. 2 Plasticity of the core materials

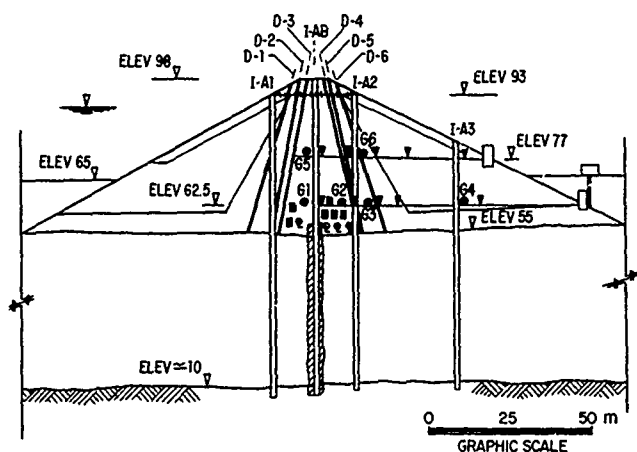
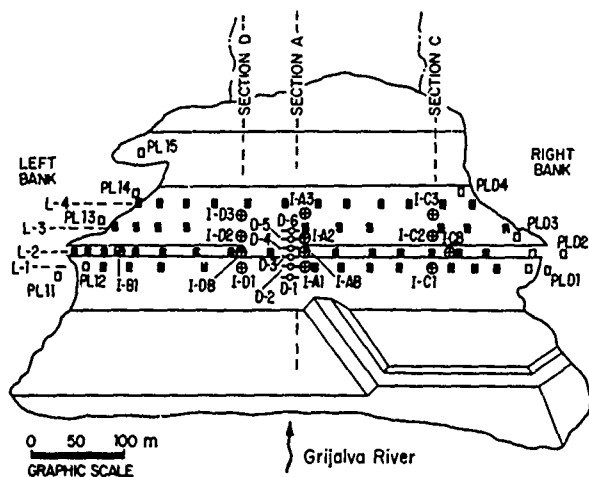
a) Cross Section A

b) Plan view

The dam is instrumented in three transversal sections A, C and D, fig 5. Each section contains four inclinometers, six clusters of instruments to measure stresses and strains, and hydraulic leveling devices at two elevations;

section A is also equipped with six cross-arms. Besides, a few pressure cells and pneumatic piezometers were also installed at certain points of the dam, and several lines of extensometers are found near the crest. On the slopes of the dam several surface reference points at rows were installed for the topographic control of the crest and slopes movements, fig 5.

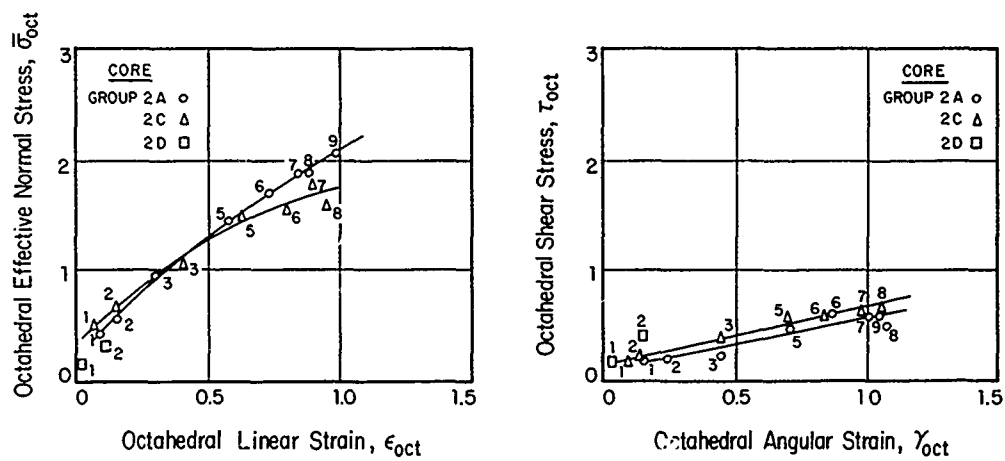
Fig. 8 Octahedral stress-strain curves for clusters No. 2 (core)

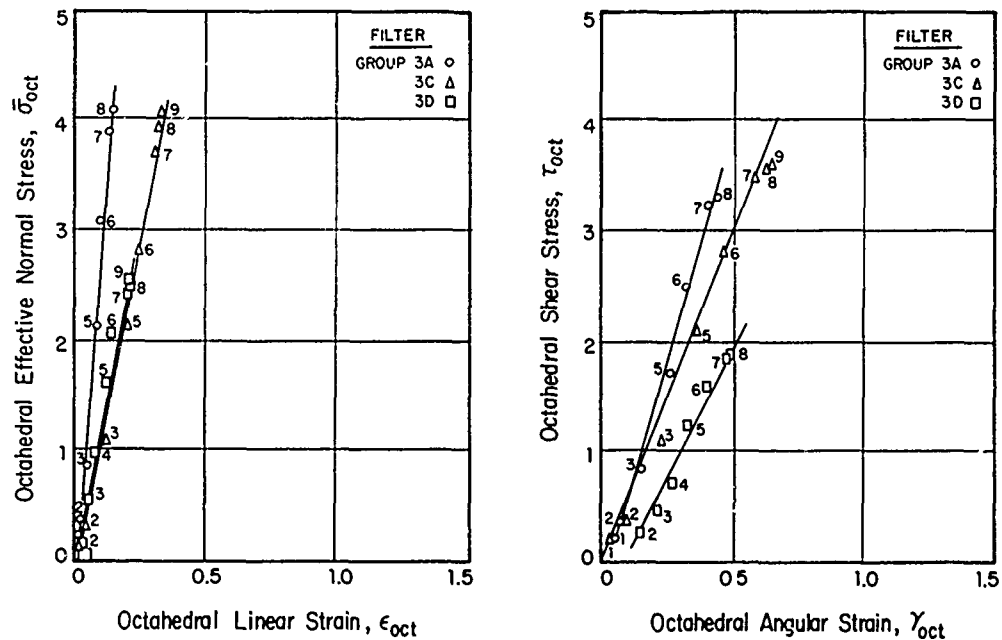
Fig. 9 Octahedral stress-strain curves for clusters No. 3 (Filter)
